Component Video / Stereo Audio Balun 500058

Quick Installation Guide

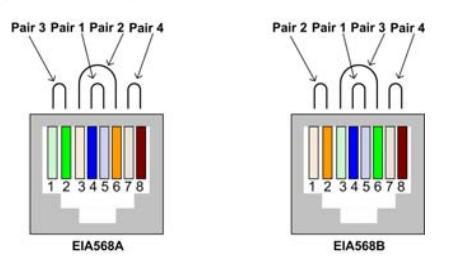
1. The pin configuration must be according to EIA 568, either A or B and wired straight-through (no crossover).

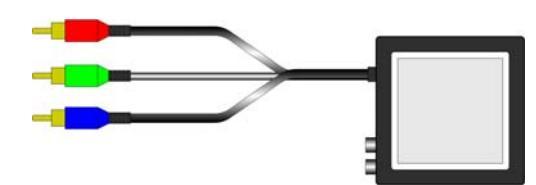
2. Plug one (1) balun into the component video output of the audio-video source according to the color code of the RCA cable leads and jacks.

- 3. Repeat step 2 for the second balun at the display side.
- 4. Complete the connection between the two baluns, using standard Cat 5E/6 twisted pair cable and connecting hardware, terminated on RJ45 plugs at both ends, ensuring that there are no split pairs or taps.
- 5. If Stereo Audio is to be connected (optional), connect left/right RCA jumper cables between the balun and the stereo audio equipment at both ends.
- 6. Power-on the component video equipment. Check the image quality and refer to the troubleshooting table below if the image quality is unsatisfactory. The following diagram shows a typical installation.
